Air Pressure and Building Envelopes

Joseph Lstiburek, Principal, Building Science Corporation, Westford, MA

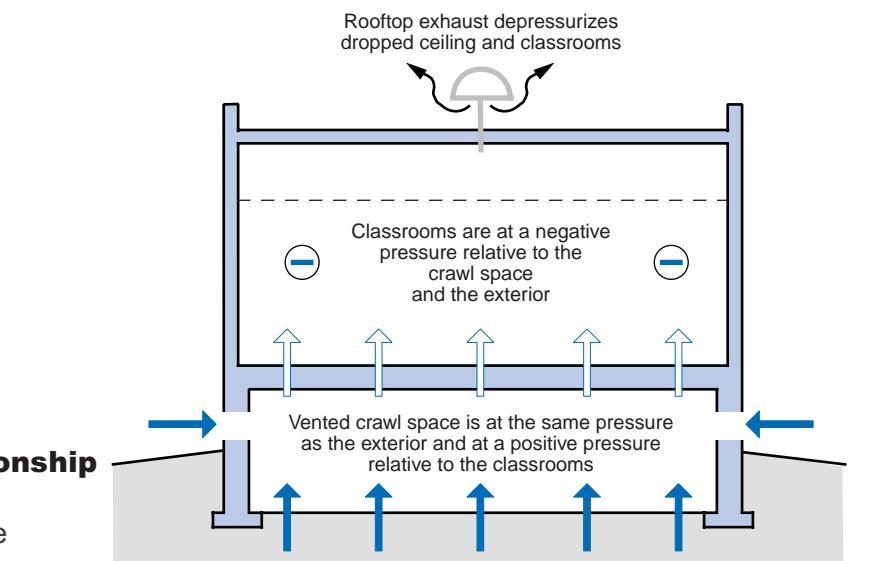
Problem Pressure Relationship

micromanometer indicated that the classroom was operating at 4 Pascal's negative with respect to the crawl space (Figure 1). Furthermore, interior wall cavities were found to operate at 1 Pascal negative with respect to the classroom.

• The classrooms in this school operate at a negative pressure with respect to the crawl space

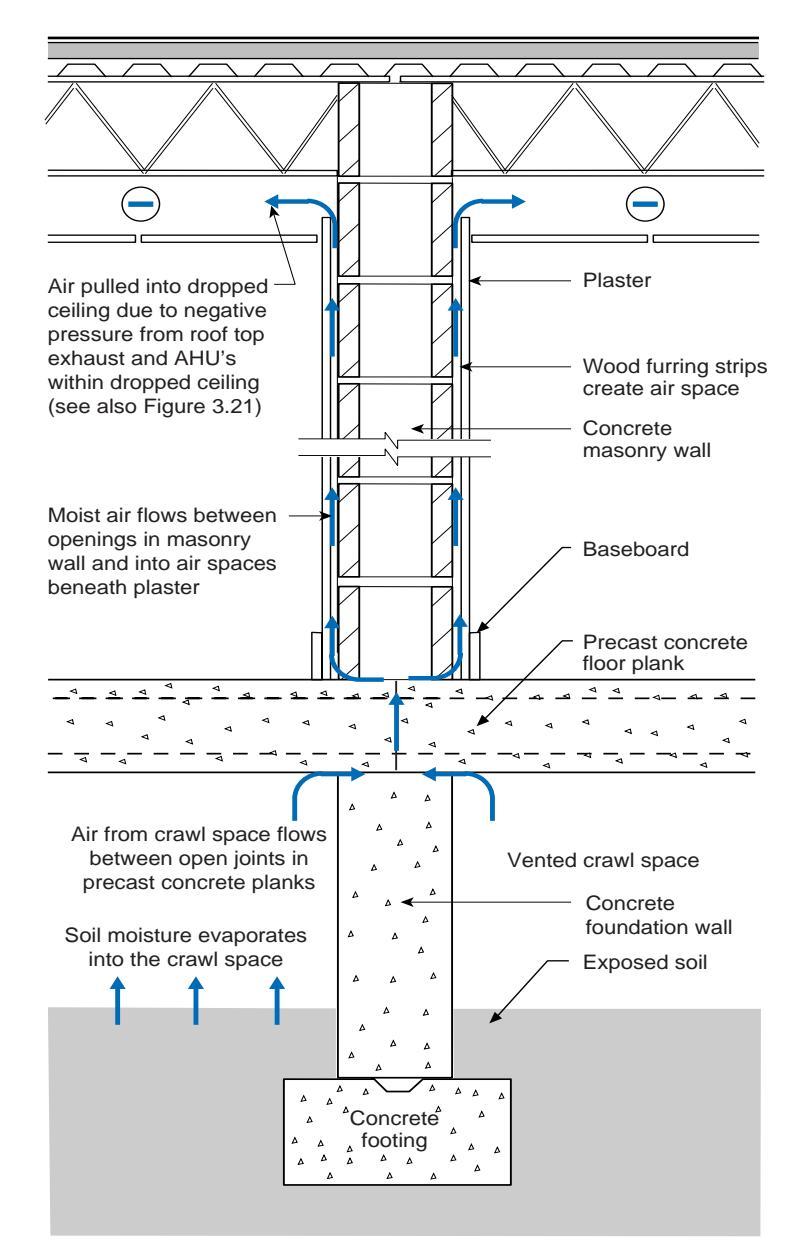
Figure 2 Moisture Movement

Moisture (the primary pollutant) in the soil in the crawl space is evaporated due to the elevated temperatures in the crawl space. Warm moisture saturated air migrates through openings in the floor slab into the air space created by the plaster and wood furring (the pathway). The air is pulled into the air space between the plaster and wood furring as a result of the operation of the roof top exhaust fans and the operation of the air handling units (the pressure "drivers"). The moisture saturated air cools once it is in the furring space leading to condensation and saturation of the building materials at this location. The saturation of the building materials leads to their deterioration and the creation of odors and other biological agents (the secondary pollutants). These secondary pollutants enter the classroom and come in contact with the teacher and students (the receptors).

This wall section illustrates moisture movement from the crawl space into the wall cavities and dropped ceiling

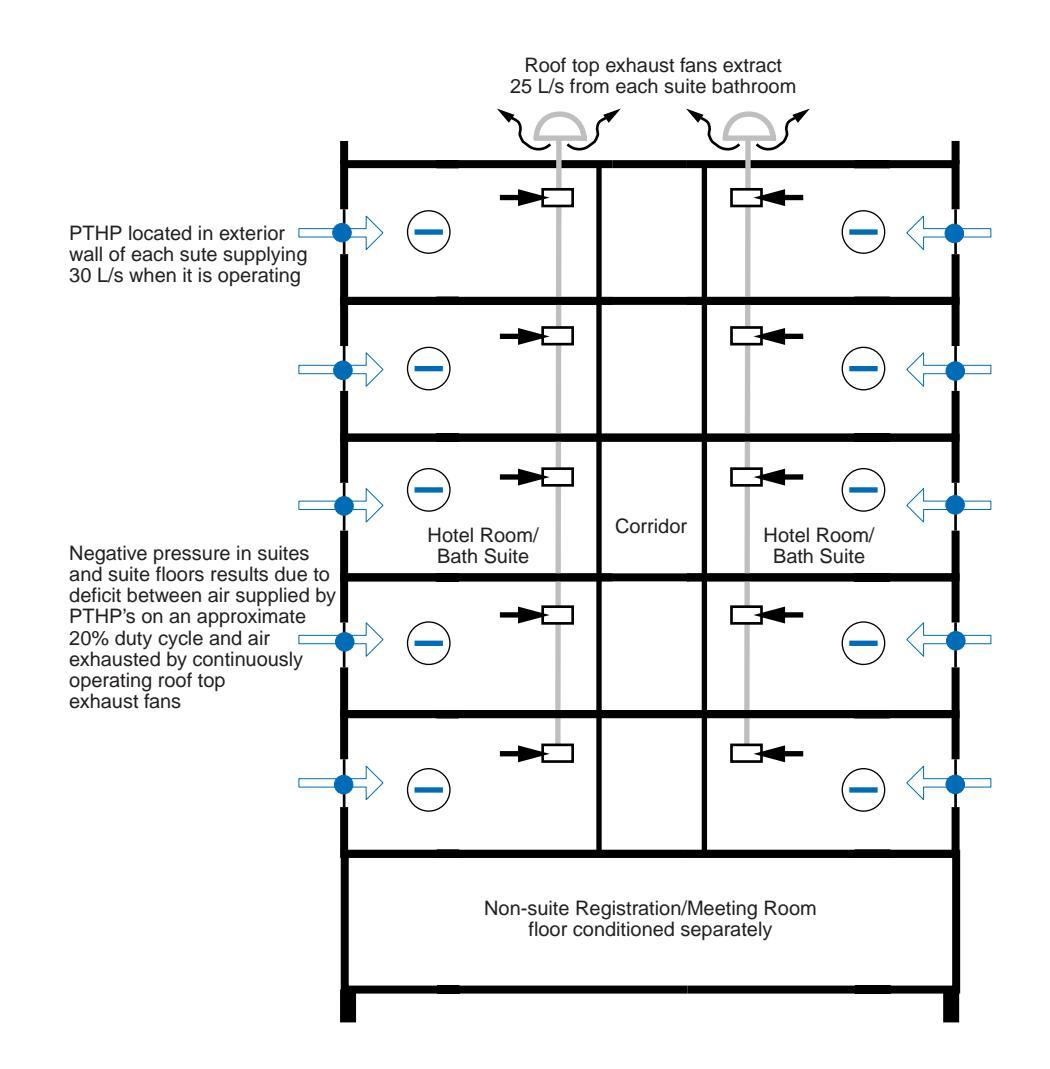
HVAC System for Hotel

The typical duty cycle of individual PTHP units was found to be about 20 percent. It was estimated that only three suite PTHP's plus the corridor PTHP operate at any one time per floor supplying only approximately 190 L/s of outside air per floor. This yields a deficit of supply to exhaust of approximately 285 L/s per floor.

- 25 L/s is extracted from each suite
- 15 suites per floor plus 100 L/s extracted from each corridor
- · 475 L/s extracted per floor
- 2,850 L/s extracted from 6 floors with suites
- Each suite's PTHP supplies 30 L/s when it is operating. One additional PTHP serves each corridor supplying 100 L/s of outside air. A total of 550 L/s is supplied per floor when all the PTHP's on a floor are operating.
- However, the typical duty cycle of a PTHP is approximately 20%, i.e. 80% of the units are off at any one time.
- When 3 suite PTHP's and the corridor PTHP are operating only 190 L/s supplied to a floor. If 475 L/s is extracted per floor, a deficit of 285 L/s exists per floor or 1,710 L/s for all the suite floors combined.

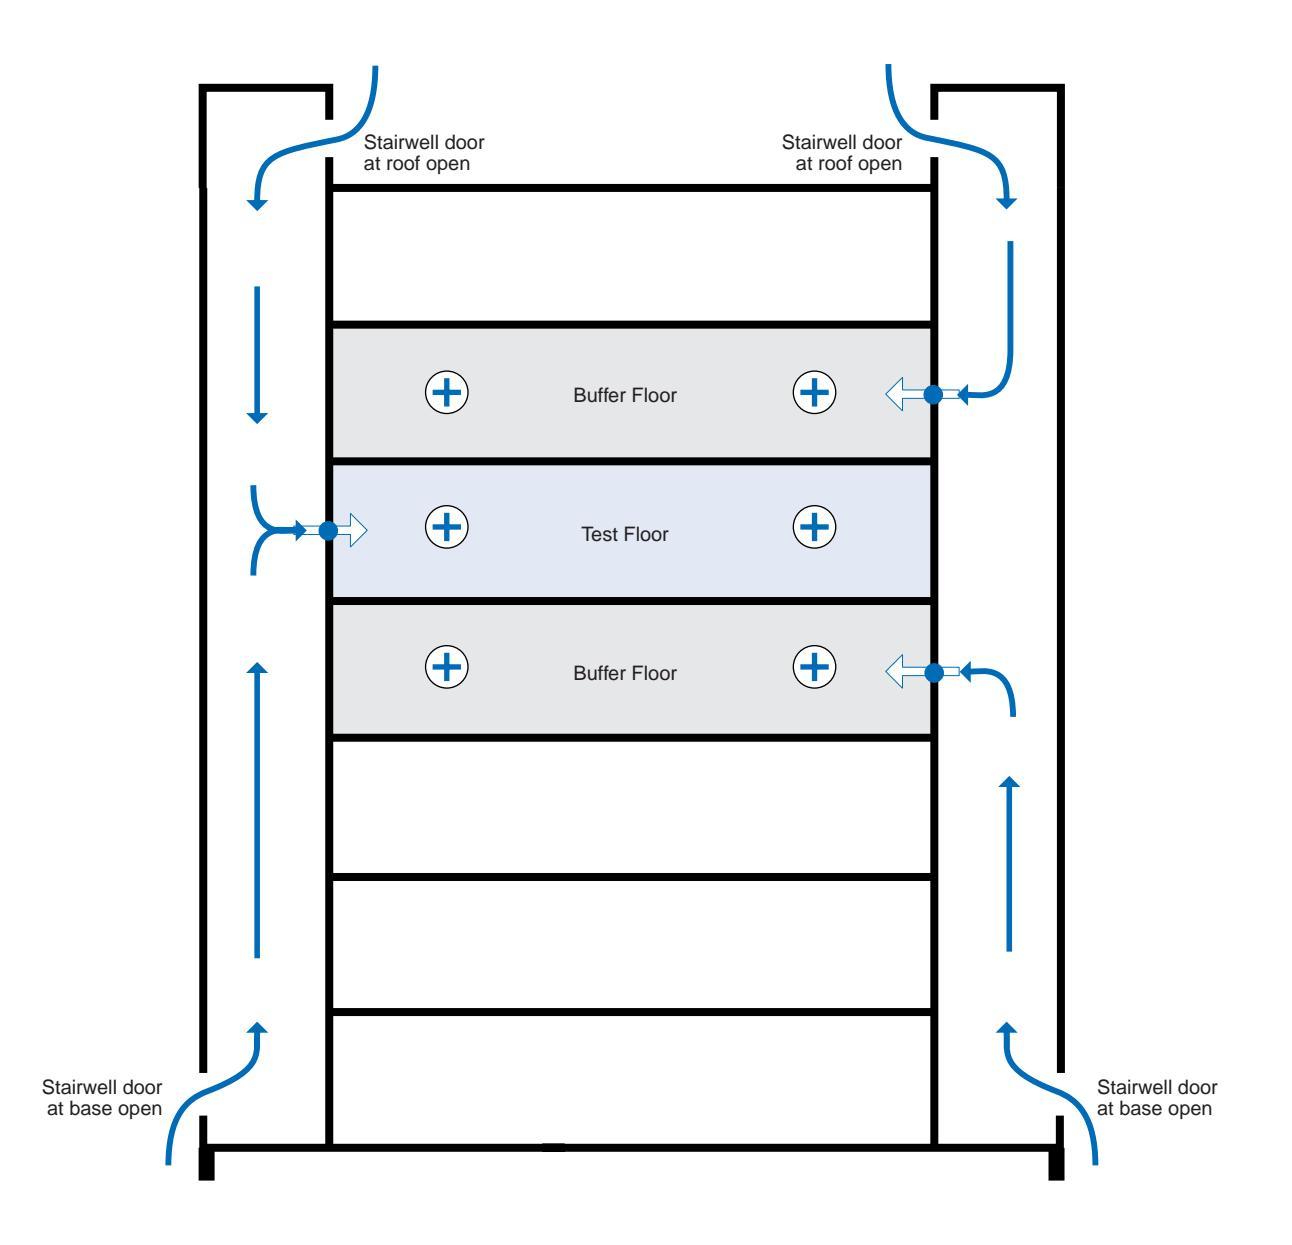
Figure 6 Air Leakage Test Zones

Leakage testing of individual floors was conducted using variable speed pressurization fans. Two types of measurements were taken. The first involved pressurizing an individual floor by extracting air from a stairwell whose exterior doors were opened to the exterior. The floors above and below the floor being tested were maintained at exterior pressure by opening all windows and corridor doors. The second type of measurement involved pressurizing the floors above and below the test floor as well as the elevator shafts to identical pressures to the test floor thereby providing isolation of test floor leakage to floors above and below. The experimental set-up is presented in Figure 6.

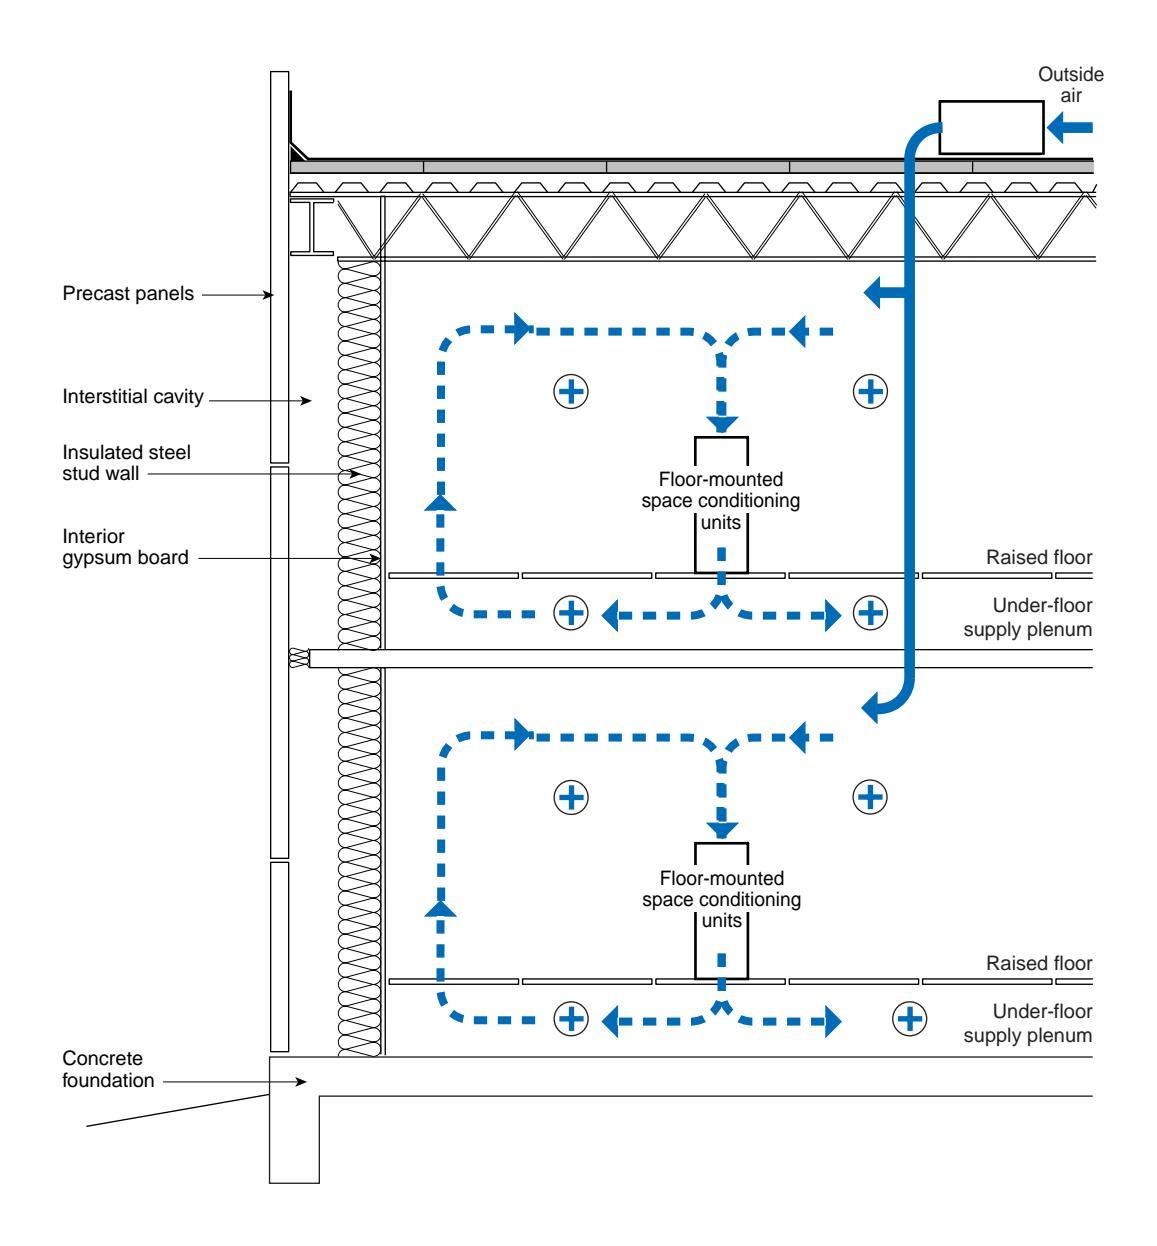
Figure 10 HVAC System as Designed

The space conditioning and outdoor air systems (Figure 10) create a pressurized enclosure that is maintained at 24 degrees C., 50 percent relative humidity year round.

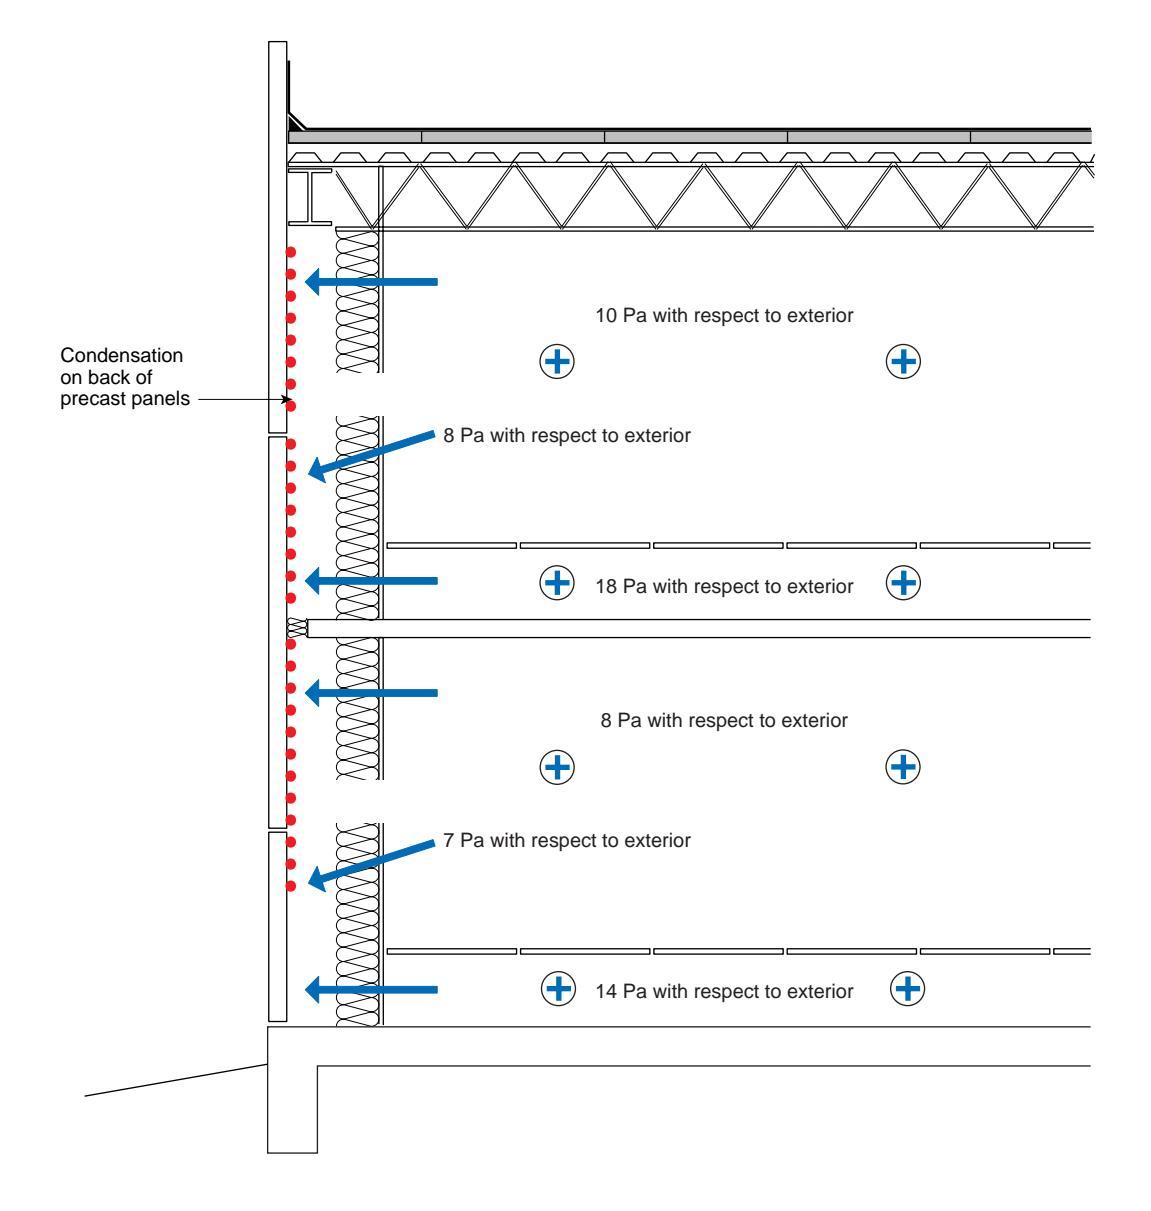
Figure 11 Unintended Pressurization of Interstitial Cavity

Air pressure differential measurements of the facility and interstitial cavities ("pressure mapping" of the facility) were taken when exterior temperatures were approximately 15 degrees C. Wind conditions were dead calm. The air pressure differential relationships as measured are presented in Figure 11.

The pressurization of both the occupied space and the area under the raised floors leads to the exfiltration of interior moisture laden air into the interstitial cavities between the precast panels and the interior insulated steel stud walls.

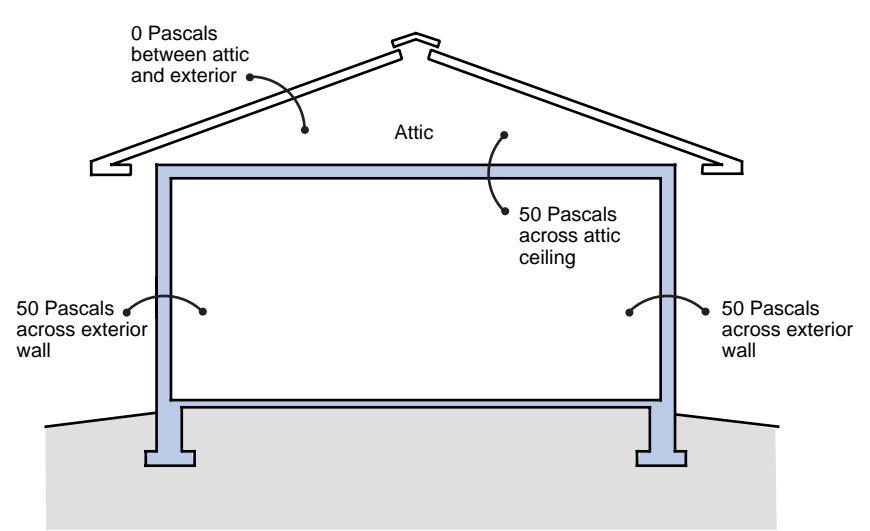
Figure 14

In this condominium development, air pressure measurements were taken across insulated ceilings when units were depressurized 50 Pascal's relative to the exterior. Measurements ranged between 25 and 35 Pascal's in the dozen units tested. These values signify extremely leaky attic ceiling construction, extremely poor attic ventilation or some combination of both.

Poorly-Defined Pressure Boundary

- Pressure boundary poorly defined ineffective at ceiling
- · Pressure boundary not continuous at ceiling

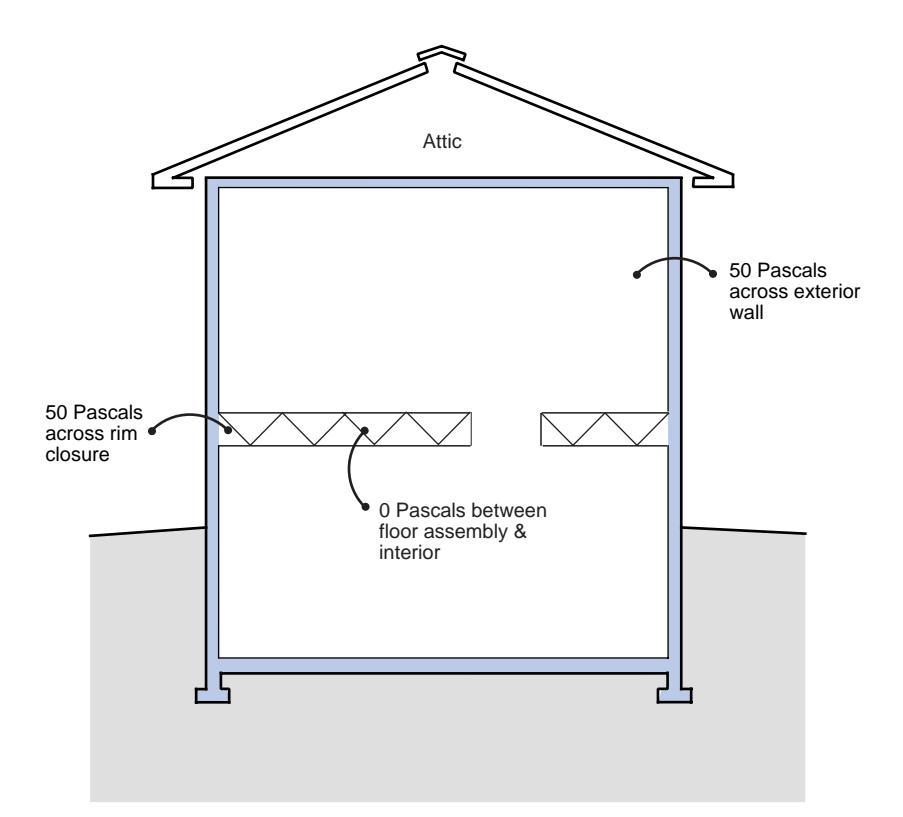
Figure 16 Leaky Rim Closure

- Floor assembly "outside" pressure boundary
- Pressure boundary not continuous at rim closure

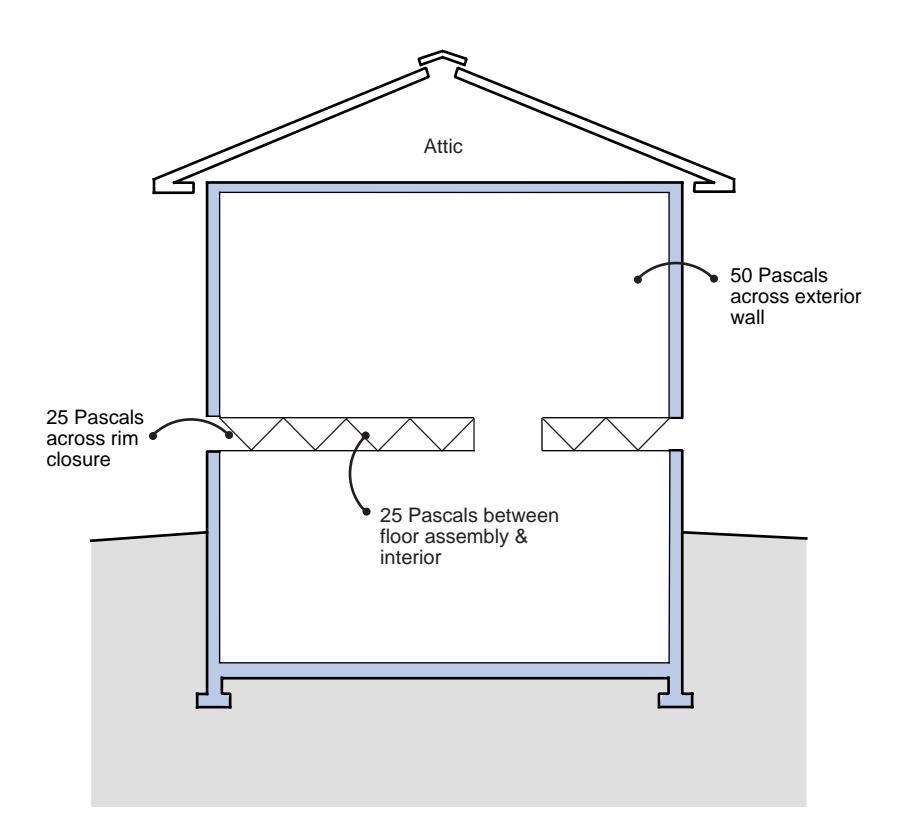
Figure 17 Pressure Boundary at Interior Floor

• Pressure boundary not contiguous with building envelope thermal boundary
