Air Pressure and Building Envelopes

Joseph Lstiburek, Principal, Building Science Corporation, Westford, MA

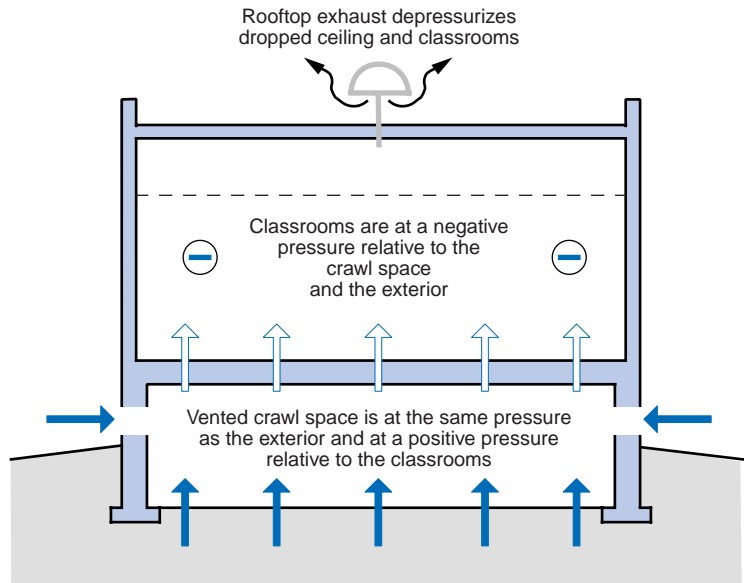
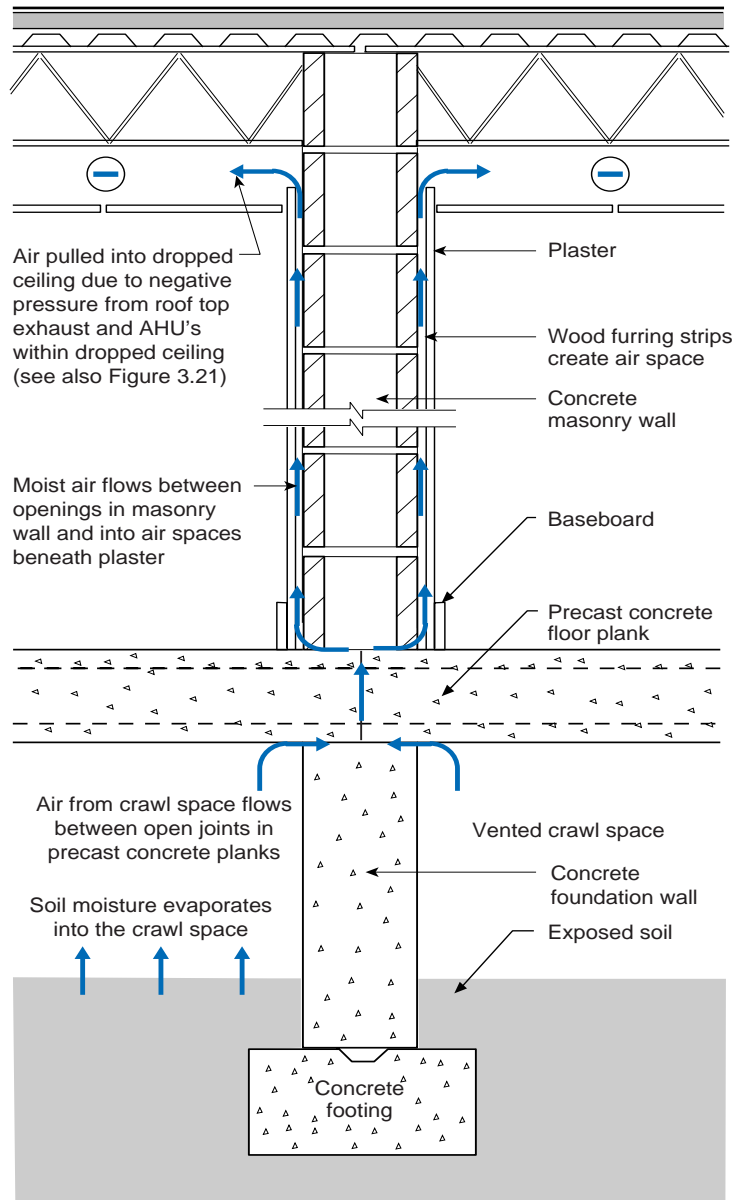
Figure 1
Problem Pressure Relationship

micromanometer indicated that the classroom was operating at 4 Pascal's negative with respect to the crawl space (Figure 1). Furthermore, interior wall cavities were found to operate at 1 Pascal negative with respect to the classroom.

- The classrooms in this school operate at a negative pressure with respect to the crawl space

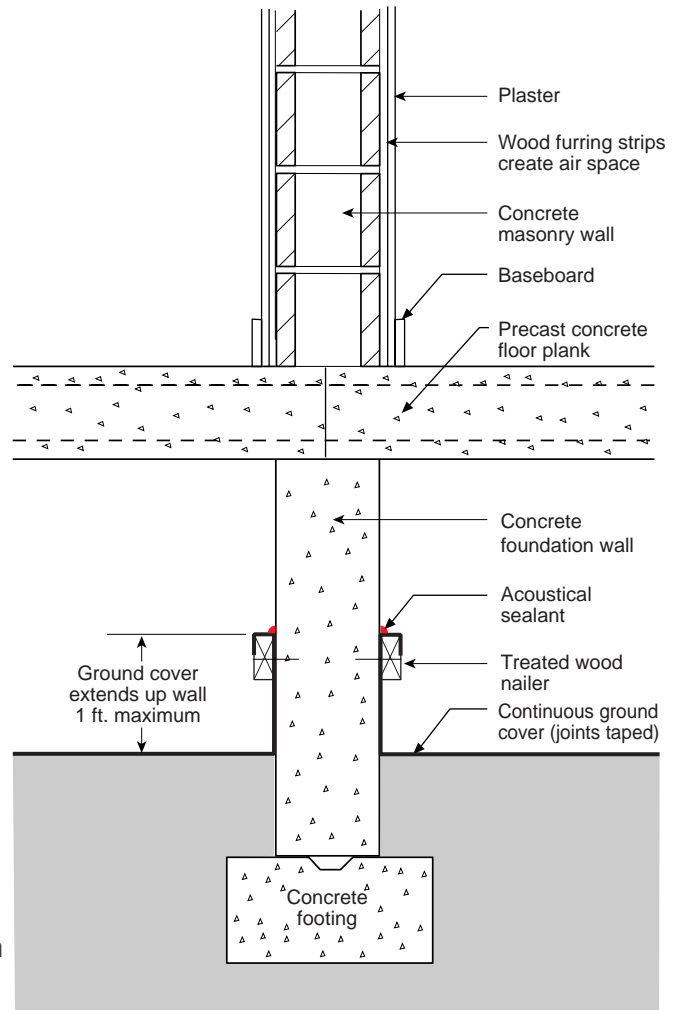
Figure 2
Moisture Movement

Moisture (the primary pollutant) in the soil in the crawl space is evaporated due to the elevated temperatures in the crawl space. Warm moisture saturated air migrates through openings in the floor slab into the air space created by the plaster and wood furring (the pathway). The air is pulled into the air space between the plaster and wood furring as a result of the operation of the roof top exhaust fans and the operation of the air handling units (the pressure "drivers"). The moisture saturated air cools once it is in the furring space leading to condensation and saturation of the building materials at this location. The saturation of the building materials leads to their deterioration and the creation of odors and other biological agents (the secondary pollutants). These secondary pollutants enter the classroom and come in contact with the teacher and students (the receptors).

- This wall section illustrates moisture movement from the crawl space into the wall cavities and dropped ceiling

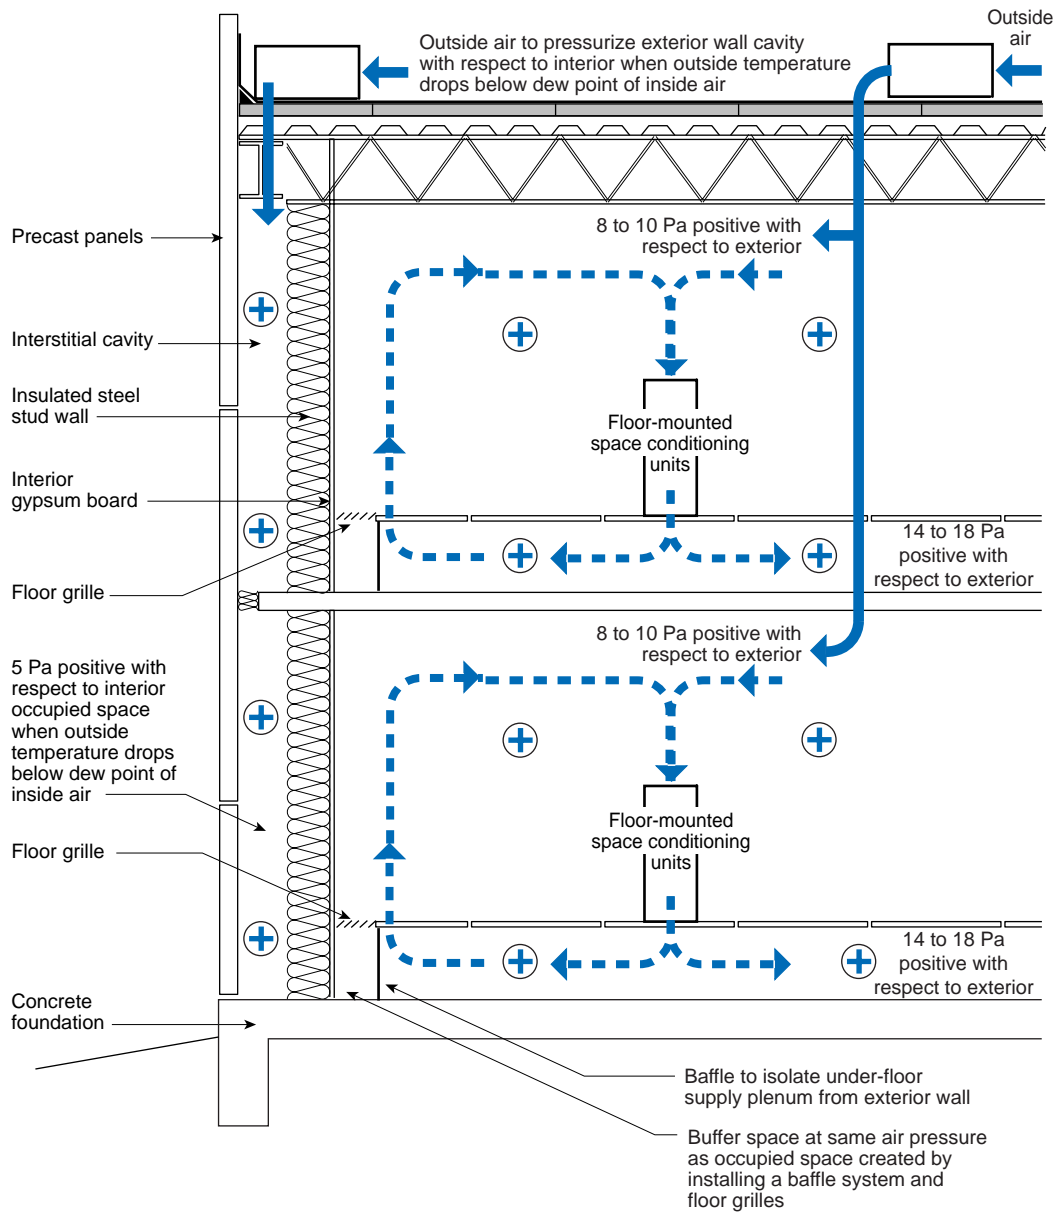
Figure 11
Unintended Pressurization of Interstitial Cavity

Air pressure differential measurements of the facility and interstitial cavities ("pressure mapping" of the facility) were taken when exterior temperatures were approximately 15 degrees C. Wind conditions were dead calm. The air pressure differential relationships as measured are presented in Figure 11.

The pressurization of both the occupied space and the area under the raised floors leads to the exfiltration of interior moisture laden air into the interstitial cavities between the precast panels and the interior insulated steel stud walls.

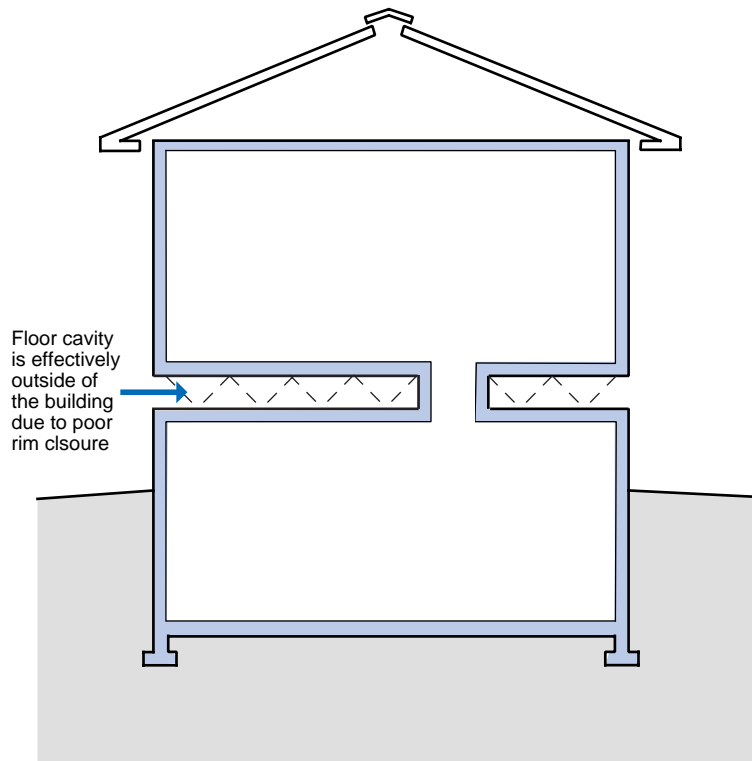
Figure 16

- Floor assembly “outside” pressure boundary
- Pressure boundary not continuous at rim closure

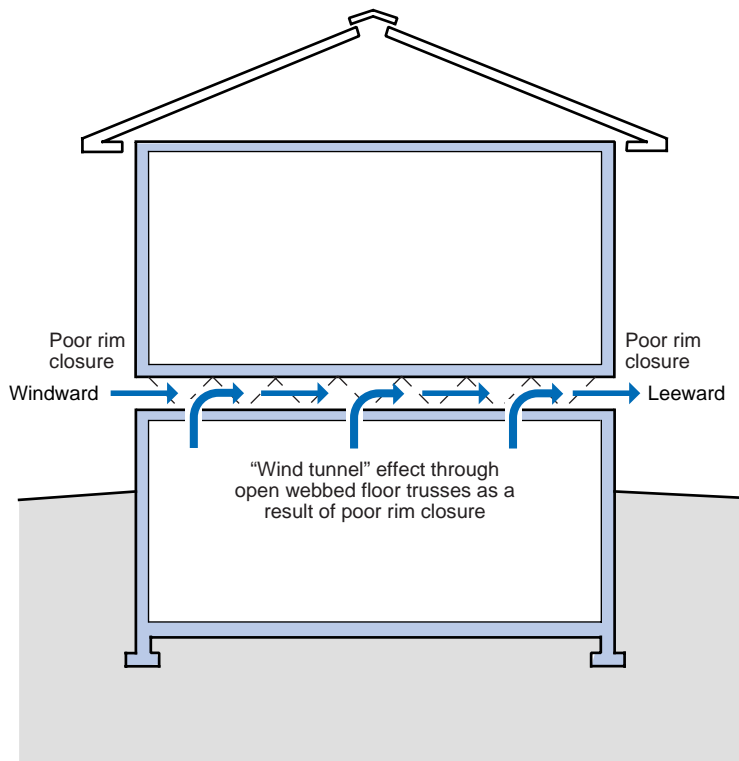
Figure 17

- Pressure boundary not contiguous with building envelope thermal boundary
